CAPITAL NEEDS ASSESSMENT

Pinewood Village
Oak Ridge Road
Lebanon, NH 03784

Pinewood Village Condominium Association
and
Moseley Associates
P.O. Box 706
White River Jct., VT 05001

September 6, 2018

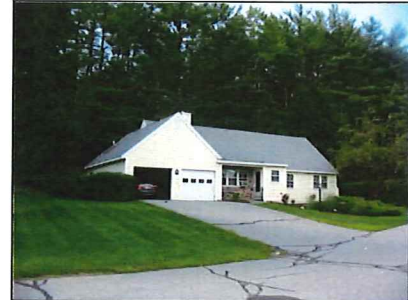
Front view of Building 1, single family residence.

Year 10: Replace the wood retaining wall located along the back of Building 1 with a new masonry retaining wall of similar size. Our budget includes excavation, disposal of the old wall, placement of a new gravel base, and the installation of a new interlocking block wall with 8 inch tall blocks.

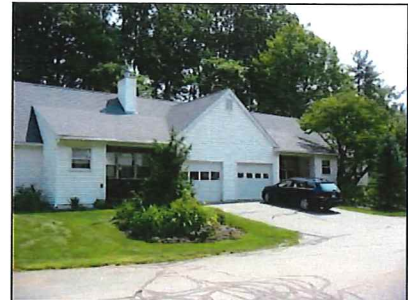
Rear view Building 29-31, duplex building.

Year 9: Replace the masonry block retaining wall located along the back of Building 29-31 with a new masonry retaining wall of similar size and style. Our budget includes excavation, disposal of the old wall, placement of a new gravel base, and the installation of a new interlocking block wall with 8 inch tall blocks.

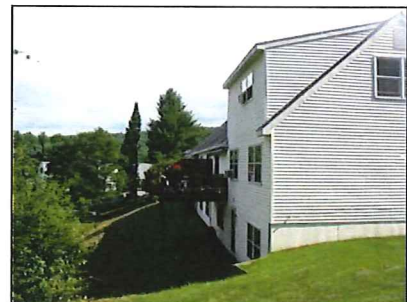
Rear view Buildings 6-8.

Year 12: Replace the wood retaining wall located at the back North-West corner of Building 6-8 with a new masonry retaining wall of similar size. Our budget includes excavation, disposal of the old wall, placement of a new gravel base, and the installation of a new interlocking block wall with 8 inch tall blocks.

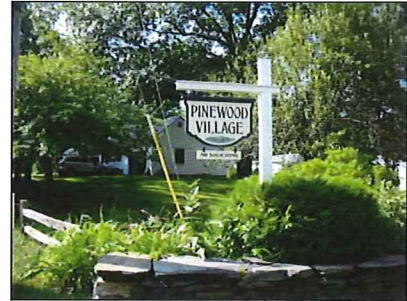
The property includes a single wood property entrance sign, estimated to be 2-3 years of age, considered in good condition and expected to last beyond the term of this assessment. As a result, we did not budget capital funds for entrance sign replacement.

Property entrance sign.

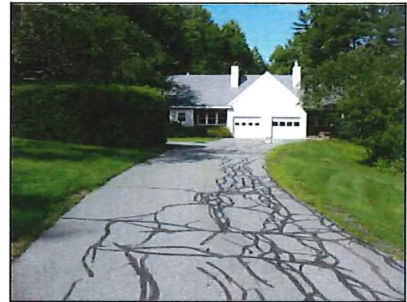
The asphalt pavement throughout the entrance roads, visitor parking areas and all of the individual driveways has been partially overlaid and selectively patched over the years, but is predominately older pavement, considered in failing condition. As a result, we recommend the following pavement work:

Typical pavement conditions.

Year 5: Reclaim and replace all of the asphalt pavement throughout the entire property. Specifically, this should include reclaiming (grind and reuse) of the existing pavement, regrading as needed and the application of (2) new courses of asphalt pavement, to include a 2 inch base course, followed by a 1 inch fine wearing course of new asphalt pavement.

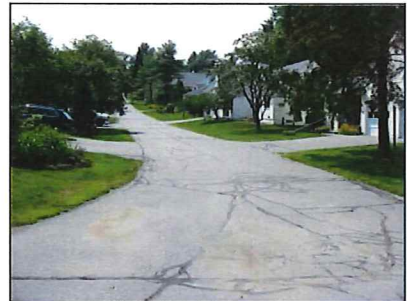
Typical pavement conditions.

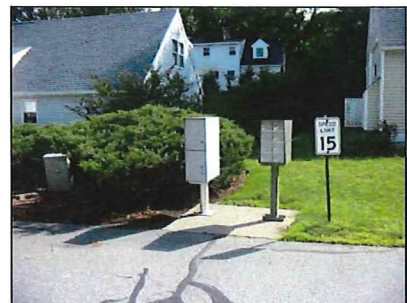
The property includes (4) exterior postal stations, each equipped with a commercial aluminum mailbox kiosk and a double parcel box. The mailboxes and parcel boxes are a mixture of ages and conditions. As a result, routine replacement of older mailbox kiosks and older parcel boxes should be scheduled as follows:

Typical mailbox kiosk with parcel boxes.

Year 9: Replace the (8) unit mailbox kiosk adjacent to Building 14-16.

Year 14: Replace the (12) unit mailbox kiosk adjacent to Building 25-27 and the (8) unit mailbox adjacent to Building 11-13.

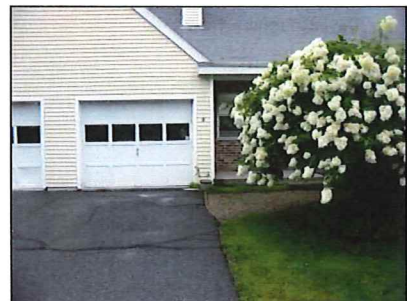
Sidewalks throughout the property are minimal, just small sections of sidewalks connecting individual driveways to entrance doors. These sidewalks are mostly older asphalt pavement; however, a few sidewalks are newer brick paver surfaces. The newer brick paver surfaces are considered in fair to good condition will likely last beyond the term of this assessment, but the asphalt sidewalk surfaces should be replaced as a part of the overall paving work scheduled for Year 5.

A few units have paver block sidewalks.

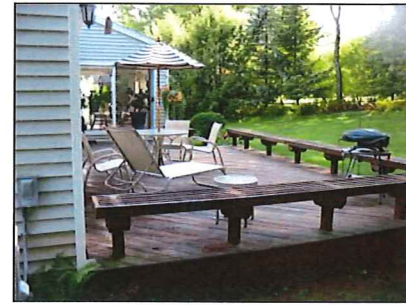
Rear deck behind Building 3-5. (Unit owner responsibility for deck replacement or repairs.)

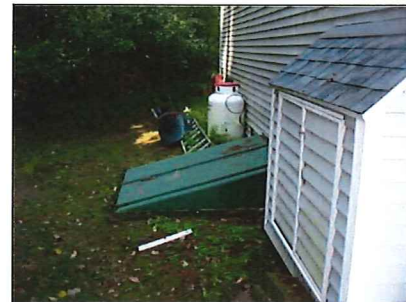
Typical bulkhead door. (Unit owner responsibility for bulkhead replacement.)

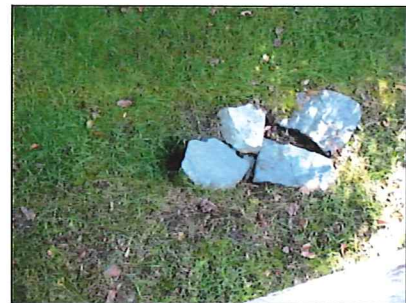
The site drainage includes (12) large concrete catch basins with subsurface piping, (3) metal culverts and natural gradient surface drainage, all of which appears to be working property. The concrete catch basins and subsurface catch basin piping is considered in good condition and expected to last beyond the term of this assessment; however, all (3) 15 inch metal culverts should be replaced in Year (5) as a part of the paving work with similar sized HDPE (High Density Polyethylene) culvert pipe.

Drainage culvert partially blocked at the front of Building 11-13.

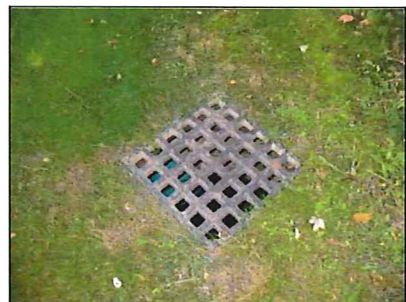
One of several drainage catch basins.

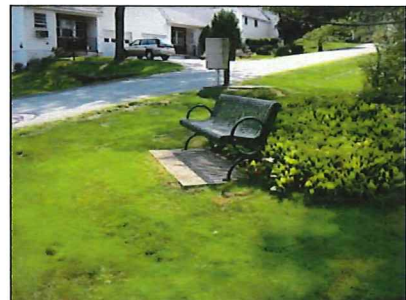
Single park bench at the property. (We did not budget for replacement, as this is not considered a capital expenditure.)

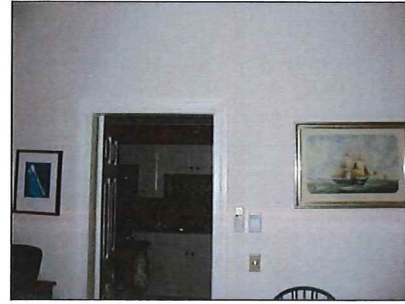
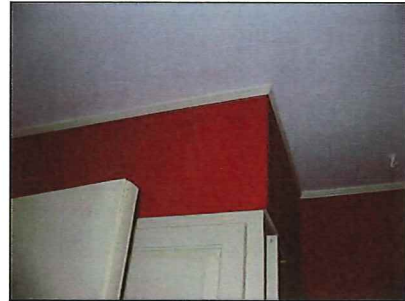
During our inspection, we noticed minor cracking at the partition wall between the kitchen and bathroom of Unit 17. This is consistent with the recent history of this building, indicating some movement or settling of the foundation in the past. The cracking is not significant and we do not consider this to be a major structural concern at this time; however, we do recommend that the association monitor the situation and retain a structural engineer should the movement or settling get worse.

Interior of Unit 17. Pictures shows cracks in drywall from movement or settlement of building.

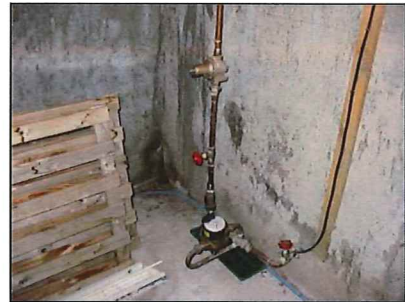
The property includes copper water mains, estimated to be 39 years of age and recommended for routine replacement in Year 16. Specifically, this should include permitting as needed, excavation and replacement with new HDPE (High Density Polyethylene) water mains.

Typical copper water mains to each building.

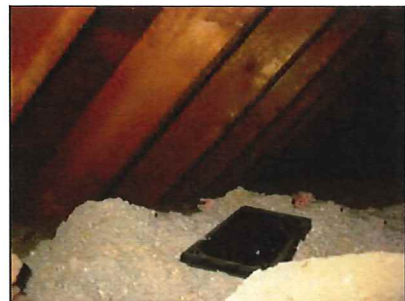
The (1) attic area we did inspect, included 10 inches of fiberglass insulation with an additional 3-4 inches of insulation of blown cellulose, equivalent to approximately R-40

Attic insulation over Unit 12. (Units originally included 10-12 inches of fiberglass insulation, but many unit owners have enhanced their attic insulation where possible.)
